**CASE REPORT**

Closing Road and Opening Trap: ProGlide Paradox in TAVI: A Case Report and Management Strategies Review

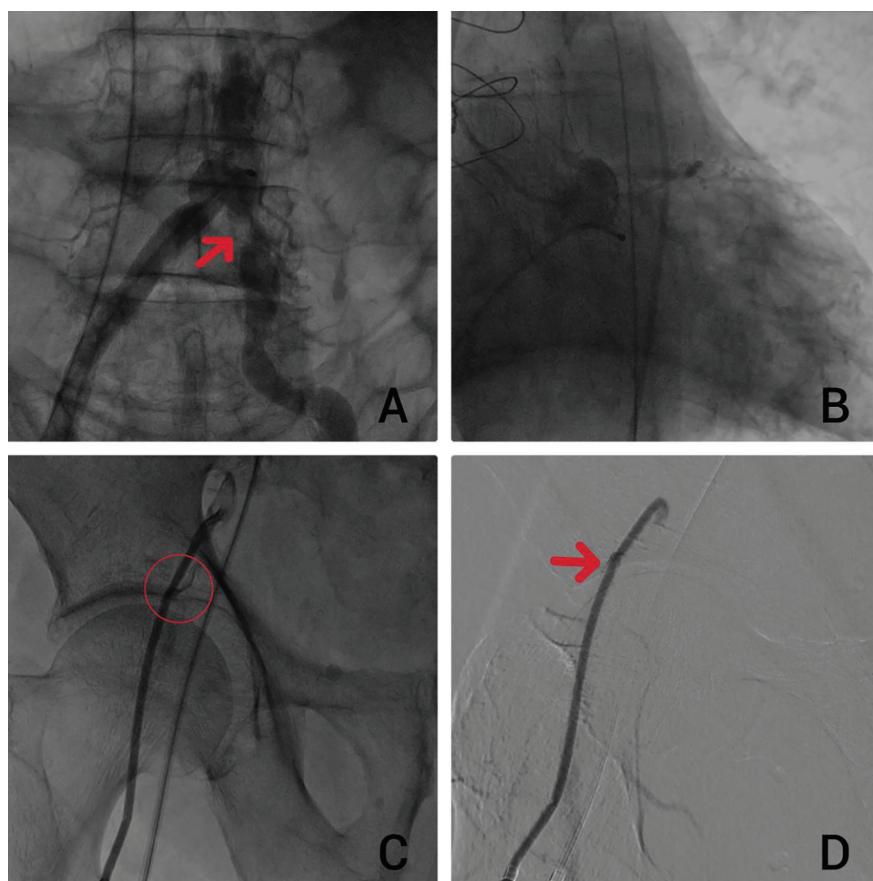
Figure 1. (A) A critical left common iliac junction stenosis indicated by a red arrow. (B) Successfully implanted TAVI valve. (C) Fluoroscopic image of the ProGlide mark on the 7F sheath and the opaque substance flowing through the holes made by the ProGlide on the sheath, in the red circle. (D) DSA image showing the ProGlide suture mark on the 7F sheath, indicated with a red arrow

DSA: Digital subtraction angiography, TAVI: Transcatheter aortic valve implantation

the ProGlide sutures inadvertently engaged the 7F sheath, effectively securing it to the vessel wall (Figure 1C, 1D). To avoid the risk of vascular injury, the patient was promptly transferred to the operating room, and the entrapped sheath was surgically removed. The patient experienced an uneventful recovery and was discharged without further complications. Written informed consent was obtained from the patient and his relatives for the publication of this case report.

In case of suspected suture entrapment, immediate reevaluation using imaging modalities such as fluoroscopy or ultrasound is recommended. Some authors have suggested that in the presence of calcified vessels, pre-closure may be optimized by balloon angioplasty or even intravascular lithotripsy to improve vessel diameter and reduce the risk of closure device misdeployment—particularly when aiming to preserve the access site, as in our case.⁵ Furthermore, awareness of this potential complication should prompt operators to apply controlled traction and, if resistance is encountered, to consider pharmacological reversal of heparin with protamine before proceeding with further manipulation.
